SPOTTED QUOLL OPEN PIT NICKEL MINE

MINISTERIAL STATEMENT 808

PERFORMANCE REVIEW REPORT

September 2023

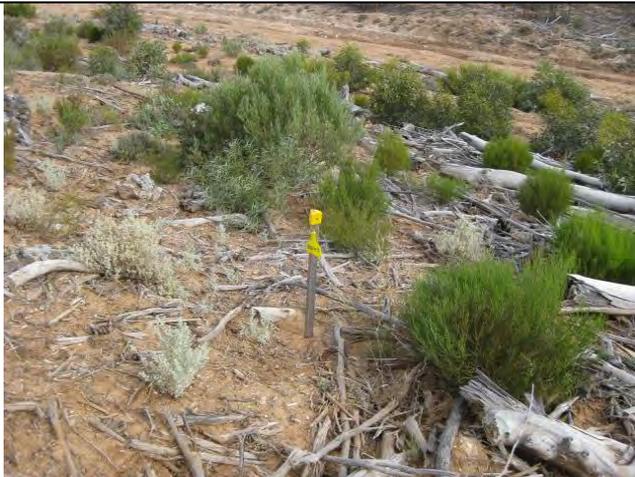
Batter rehabilitation Spotted Quoll waste dump

The 2022/2023 annual rehabilitation program was successfully completed from late autumn to early winter 2022, in order to take advantage of cool seasonal conditions and winter rainfall. The rehabilitation program activities included earthworks, tube stock planting from local provenance seed, signage and setting up of photo monitoring of recent rehabilitated sandpits.

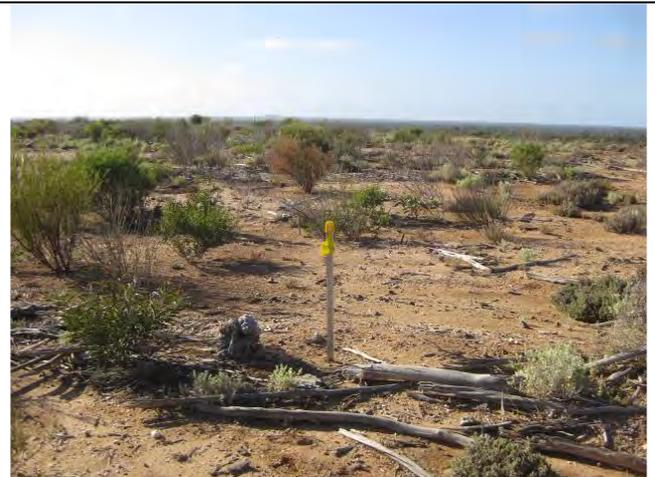
Spotted Quoll waste dump rehabilitation top surface

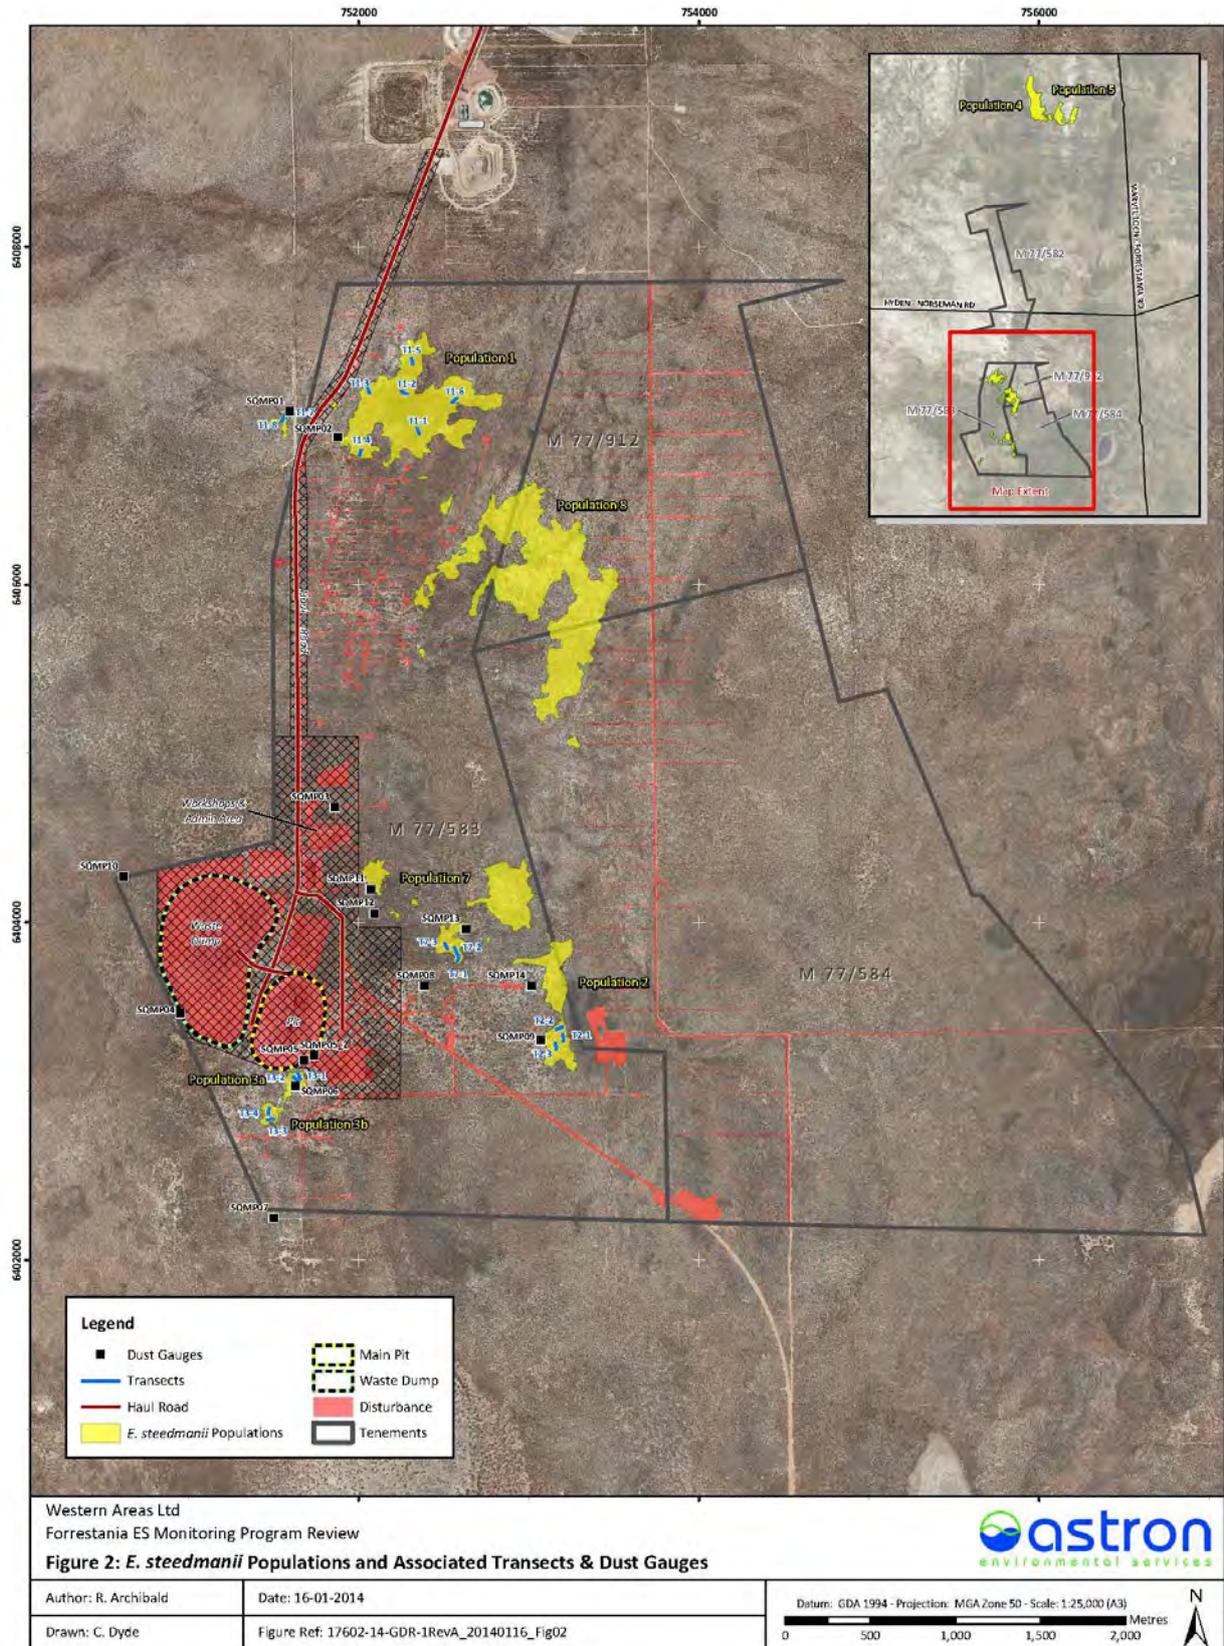
Figure 2: Spotted Quoll project – general site layout plan

Figure 2 shows the general layout of the Spotted Quoll project.

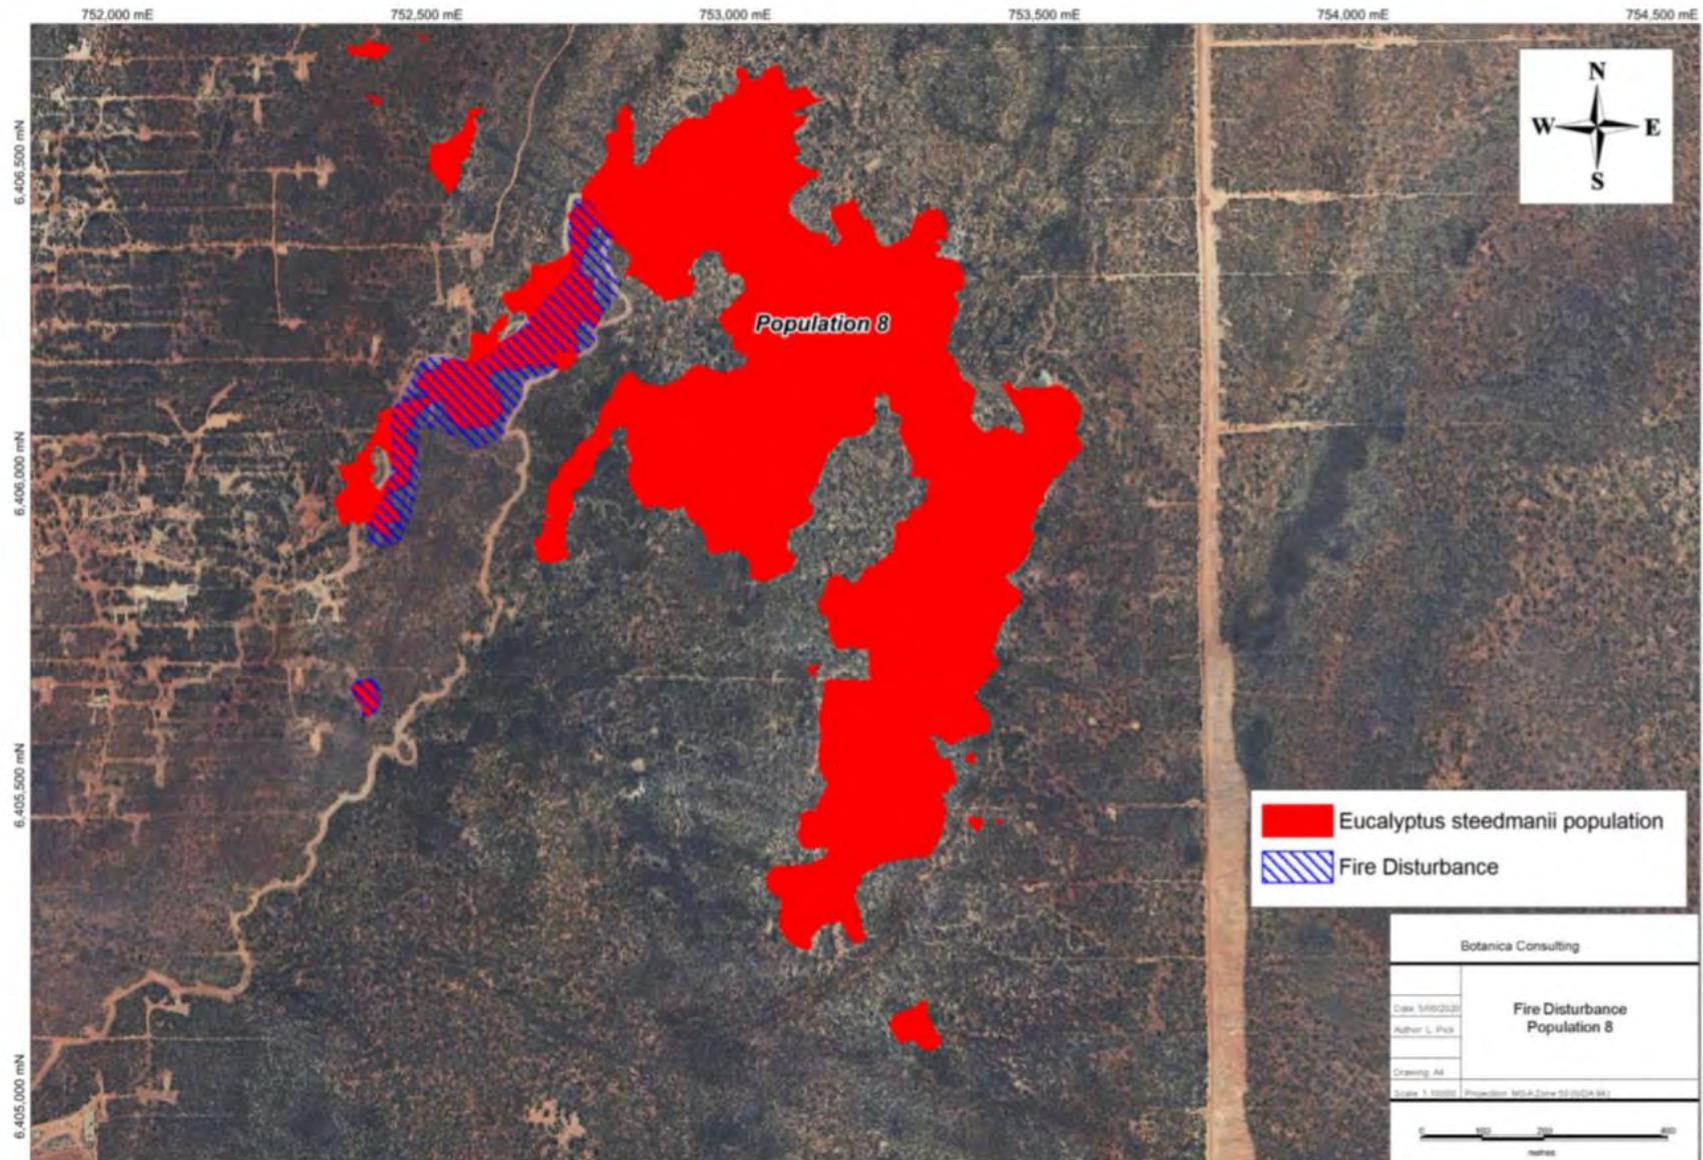
Figure 3: Fire disturbance identified within Population 8 (Botanica 2020)

In February 2020 there was a significant bushfire event within the Forresteria region and beyond. The fire was likely to have been caused by lightning strikes (DEFS, 2020) and resulted in impacts to FNO infrastructure, including Spotted Quoll mine infrastructure, as well as surrounding native vegetation. Among the native vegetation impacted, a portion of *E. steedmanii* Population 8 located to the east of Spotted Quoll mine infrastructure was impacted (Figure 3). This impact was caused by firebreaks cleared by the Department of Fire and Emergency Services to track the fire and direct fire damage.

Following the event, Botanica Consulting were engaged to undertake assessment of the damage to Population 8 and provide advice on potential operational measures that could add further protection to this community and/or aid in the recovery of this population. The assessment determined that approximately 3.6 ha (6.7%) of Population 8 had been burnt during the event. More refined mapping by WSA determined the area of disturbance is slightly larger (i.e., approximately 4.74 ha [9%] which includes both Department of Fire and Emergency Services firebreaks created to track the fire [0.64 ha] as well as burnt areas [4.1 ha]). Botanica concluded that given Population 8 comprised mainly mature seeds prior to the fire, the potential to regenerate from seed is possible. Evidence of this occurring in the past is shown by the 1994 fire that swept through Forresteria affecting known populations, which regenerated with many trees now present in mallee form. Botanica further concluded that given the small proportion of the population impacted it is unlikely that the bushfire will result in a significant impact to *E. steedmanii*. Photo point monitoring of Population 8 commenced in 2021. Photo monitoring has recorded the early stages of regrowth of the native vegetation.

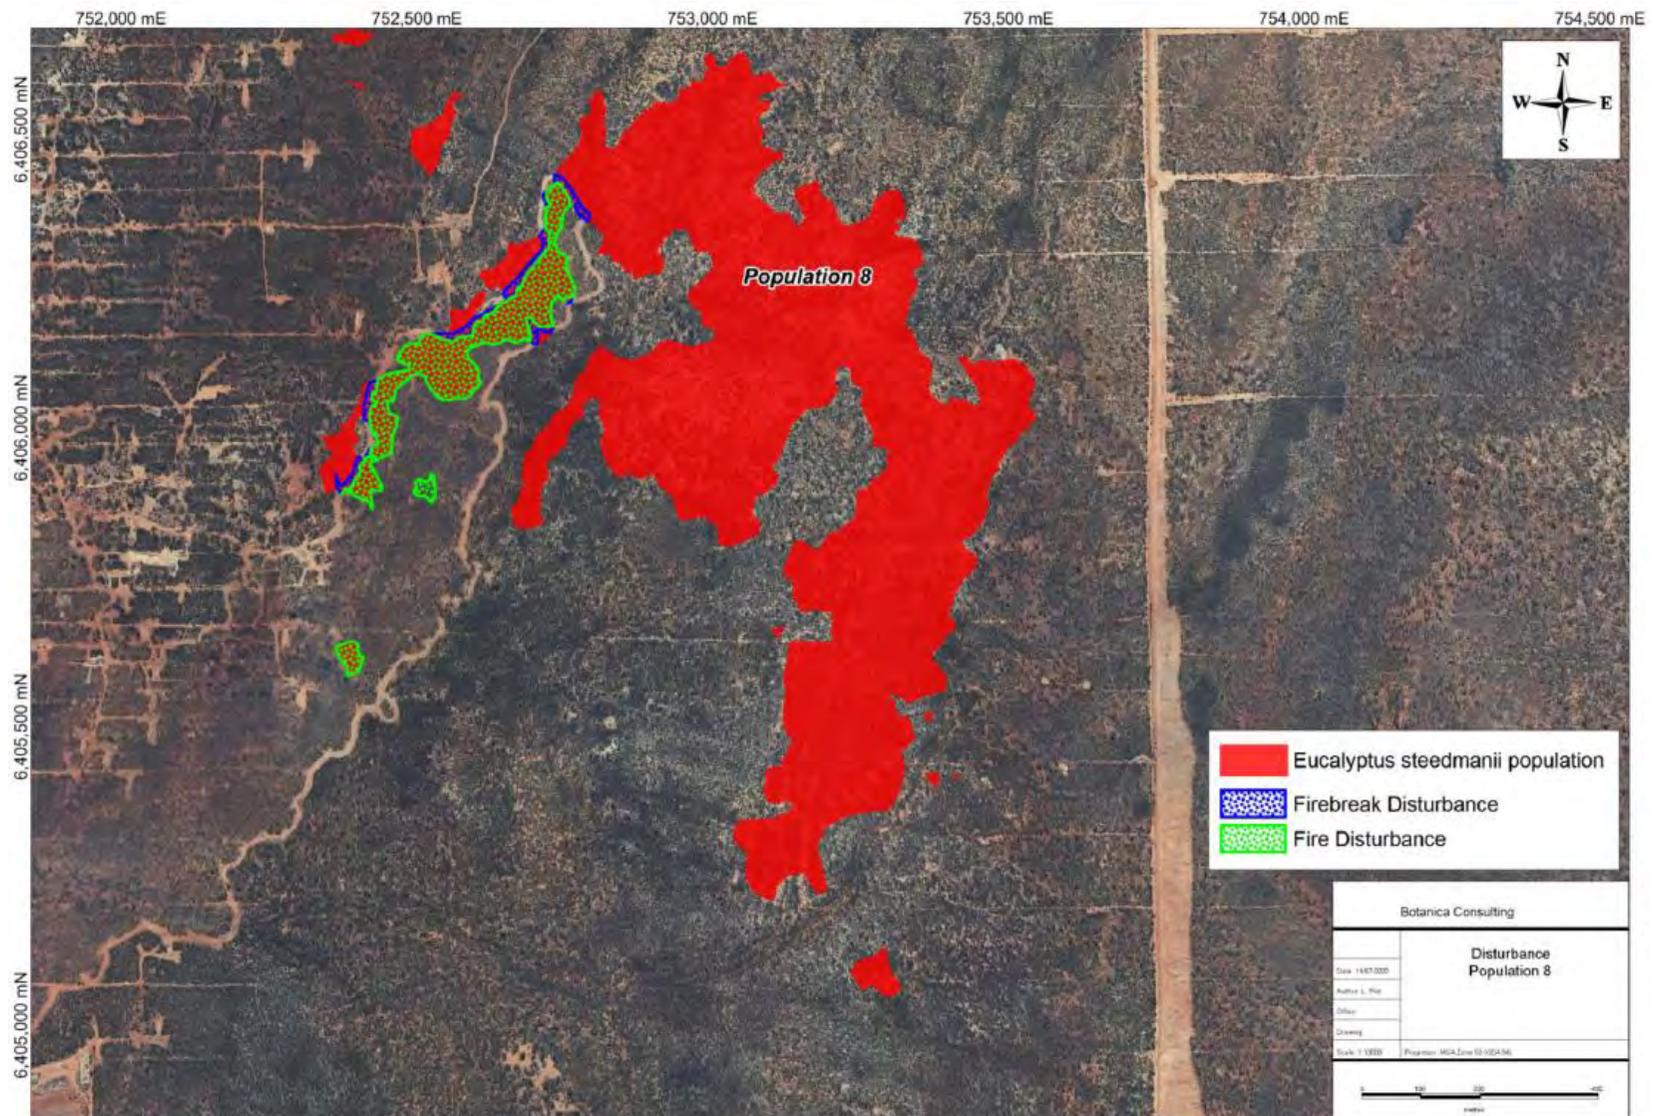
Figure 2: Fire and firebreak disturbance identified within Population 8

In March 2020, Jim Williams from Botanica carried out an assessment of the recently burnt areas within or nearby to the *Eucalyptus steedmanii* populations, which included Population 3 and Population 8. The area was traversed on foot to visually assess the damage caused by both fire and firebreak construction. The extent of bushfire damage in relation to the populations was mapped using a held hand Garmin GPS device and photographic records were taken of both fire and firebreak construction damage.

Population ID	Population area (ha)	Population area burnt (ha)	Population area cleared for firebreak (ha)	Percentage of population impacted (%)
Population 1	32.9	0	0	0
Population 2	9.2	0	0	0
Population 3	2.7	0	0	0
Population 4	115.4	0	0	0
Population 5	54.2	0	0	0
Population 6	102.0	0	0	0
Population 7	14.2	0	0	0
Population 8	52.5	3.6	0.6	7.9
Total	383.2	3.6	0.6	1.1

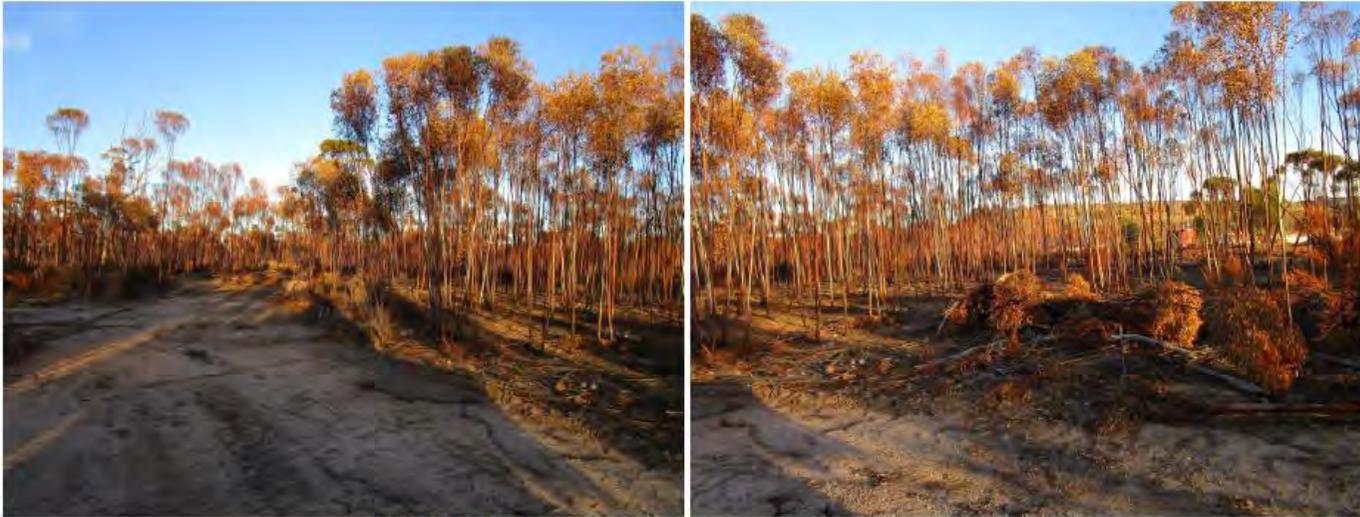
Plate 1: Fire and firebreak damage evident near Population 3

The first area that was visited was Population 3 which is located directly south of the Spotted Quoll mine site (Figure 1). This population had not been affected by the bushfire but the fire had come close to population with fire damage observed for other common mallee species near the population (Plate 1). A firebreak has also been constructed near this population; however, no *Eucalyptus steedmanii* plants were damaged (Plate 1). The second area that was visited was Population 8 which is located approximately 1.5km north-east of the Spotted Quoll mine site (Figure 1). Population 8 had been affected by both bushfire and firebreak construction (Figure 2 and Plate 2). The extent of fire disturbance of each population is specified in Table 2. The area of fire and fire break construction disturbance represents a 7.9% impact on the population extent for Population 8 and 1.1% impact on the total known extent of *Eucalyptus steedmanii* populations.

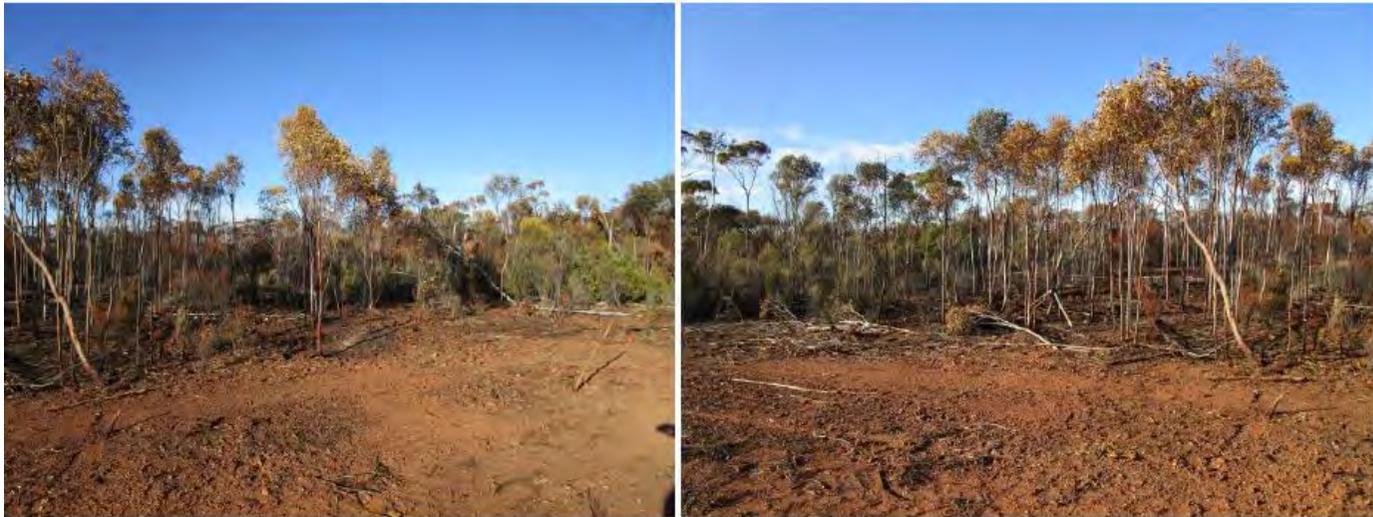
Plate 2: Fire and firebreak damage evident at Population 8

- Maps and spatial data of known occurrences of *Eucalyptus steedmanii* should be provided to local and state fire services to assist with ongoing fire management of *Eucalyptus steedmanii* populations (in accordance with DAWE Conservation Advice recommendations).

- Establish photographic monitoring points within burnt areas to assess regeneration of populations over time.
